## FOUNDATION EROSION OF HOUSES DUE TO ACTION OF WIND

### Abstract:

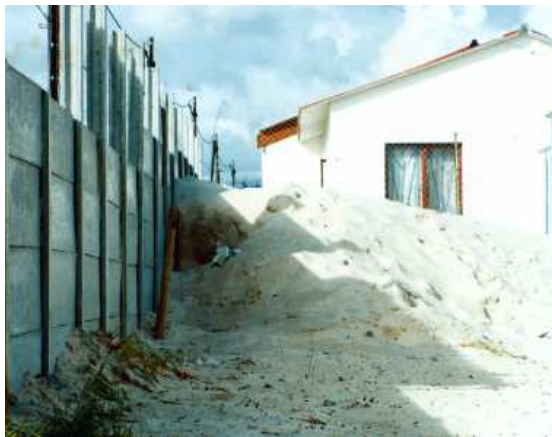
a)

Several properties and open spaces contained wind-borne dunes of substantial sizes (Fig. 1a). In some places, the height of the deposit was up to 2 metres above the original ground level, and some sections of tarred roads were also totally covered by sand. According to residents, the process of unwanted accumulation of huge volumes of sand was typically very rapid, making any removal efforts fruitless. Several houses affected negatively by the erosion process were observed. Fig. 1b presents a complete failure of floor slab with worn-away supporting soil, which subsequently also triggered the collapse of walls.

Figures 1a to 1b: Effects of sand deposition and erosion

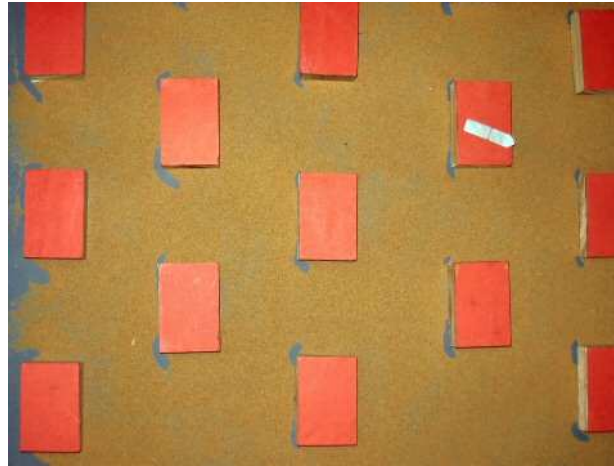
The investigation was carried out using a sand-scour technique. The erosion patterns which were obtained for both experimental arrangement of houses and for various wind directions were documented photographically. A sample of such a pattern is presented in Fig. 2.

Figure 2: A sample of erosion pattern

A general confirmation of the full-scale observations was apparent in respect to the role of open, undeveloped spaces. The photographic documentation obtained from tests was subsequently digitised and converted to a graphical form. The full paper presents samples of the erosion patterns and quantitative analysis of the respective results.
